Practical Completion Report

Lot 11 Sample Street. Somewhere

PCI SAMPLE REPORT

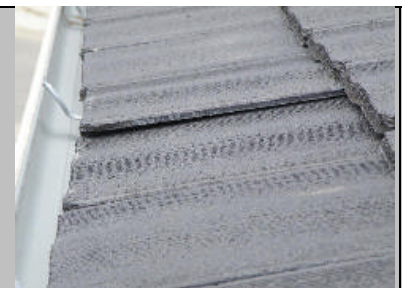
Tile over the garage boundary wall is not sitting down correctly.

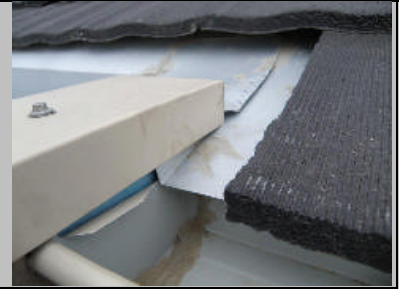
Gaps to the parapet flashing at the garage wall.

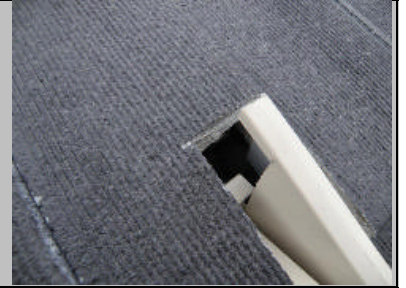
Flashing is missing where the front eave returns back to the brickwork at the front left of the house.

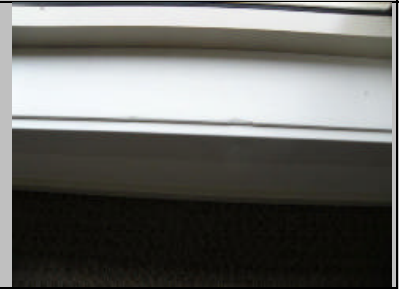
Reveal is damaged.

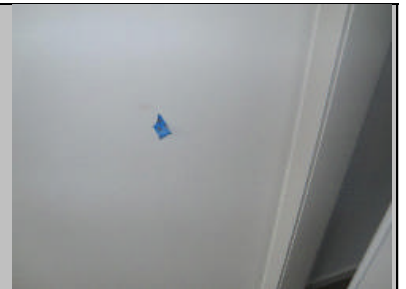
Mark on the wall left side of the robe.

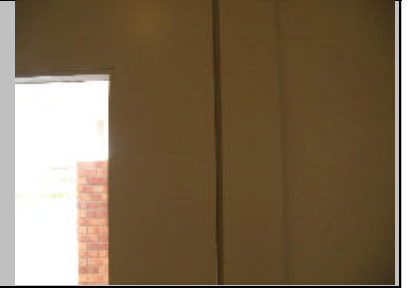
The door binds.

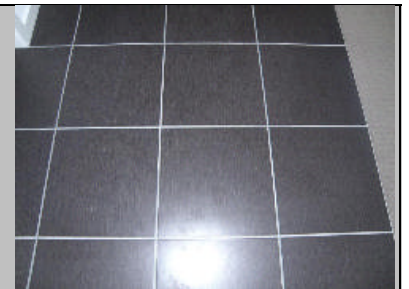
Paint marks on the tiles opposite the sliding door.

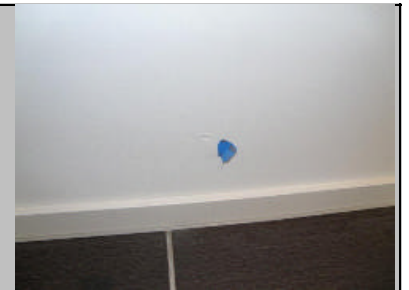
Impact damage was noted beside the sliding door.

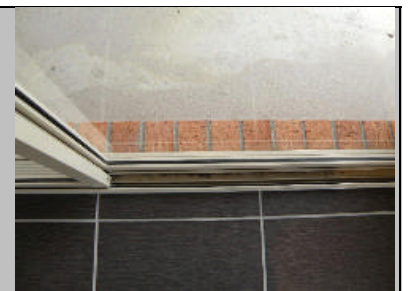
Sliding door track needs cleaning.

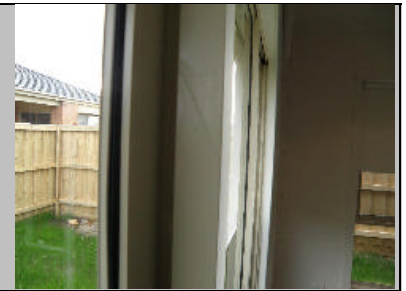
Scratched centre interlocking mullion rear sliding door.

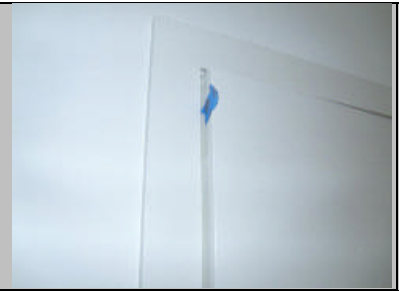
Binding at the top.

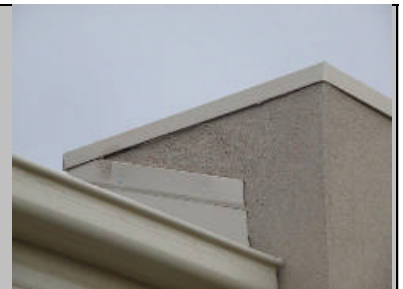
Inconsistent texture finish above the front porch.

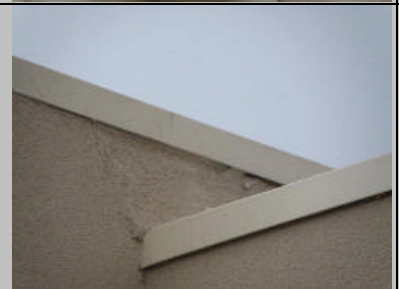
Inconsistent texture finish above the front porch.

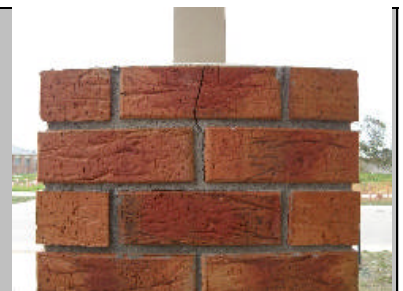
Cracked brickwork to the porch pier.

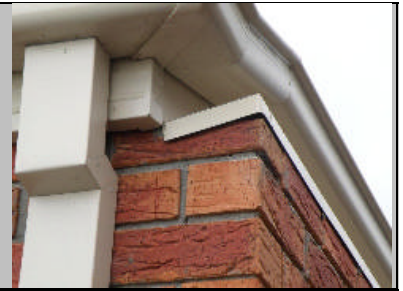
External wall flashing not secured front right.

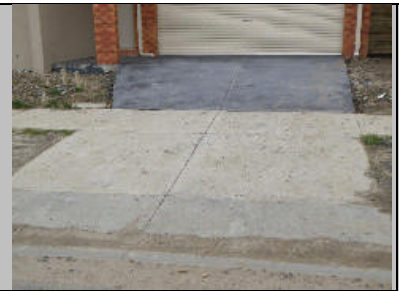
Driveway, front porch and crossover are dirty.

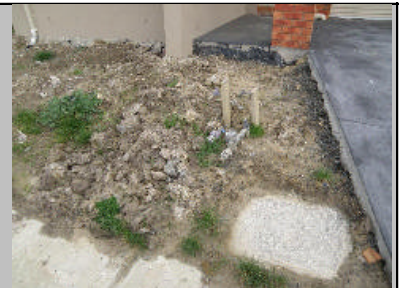
Incomplete to the front yard and it appears the letter box has not been built.

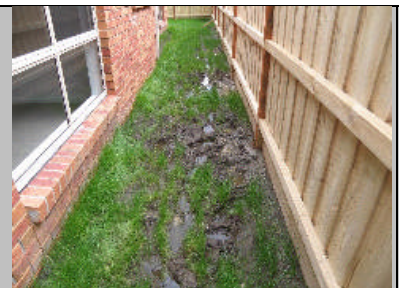
Water is ponding on the ground.
